The Rivers

Cascumpec Bay Watershed
Association Inc.

August 2021
Volume 6 Issue 3
By: Nora Harper

Spreading Rock at Marchbanks

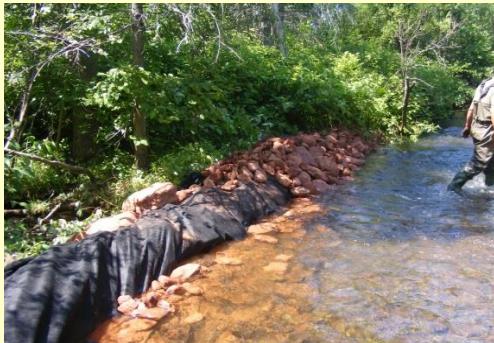
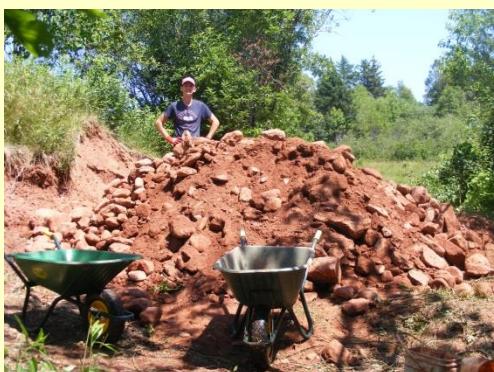
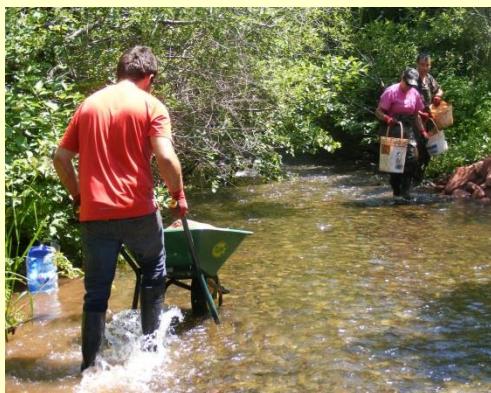
CBWA identified an erosion issue on a waterway at Marchbanks. The bank was degraded, disrupting the normal flow pattern. With the assistance of students from the STARS program, CBWA staff re-established the bank with rocks and filter-fabric - therefore re-directing the stream flow and deepening the channel. We want to extend a sincere thank you to the STARS group - the students braved the bugs and the hot summer temperatures to complete the job.

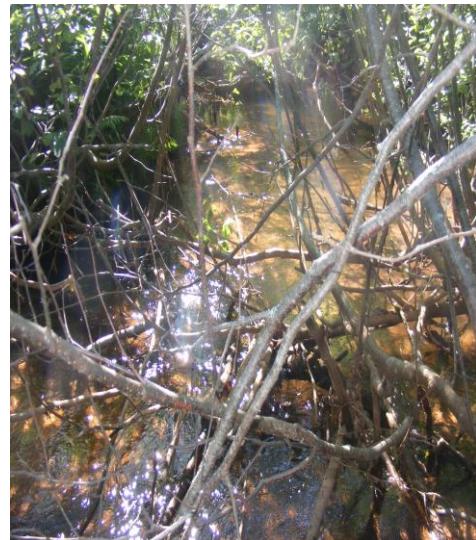
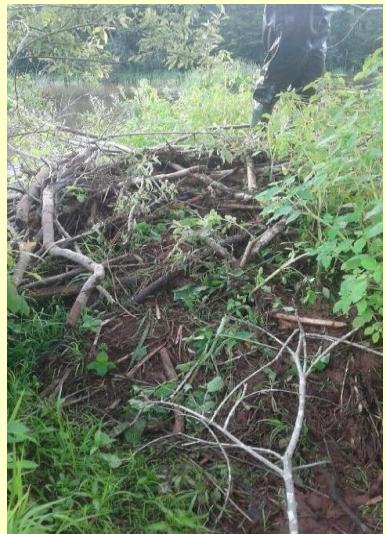
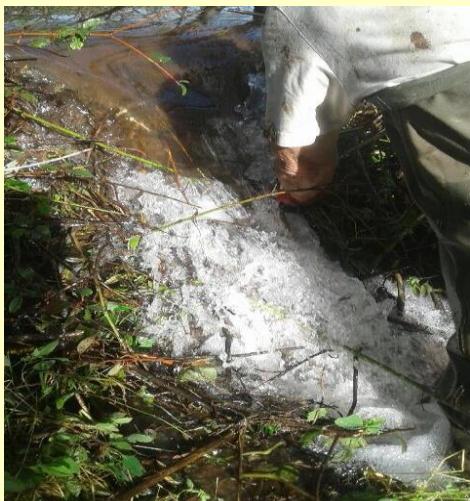
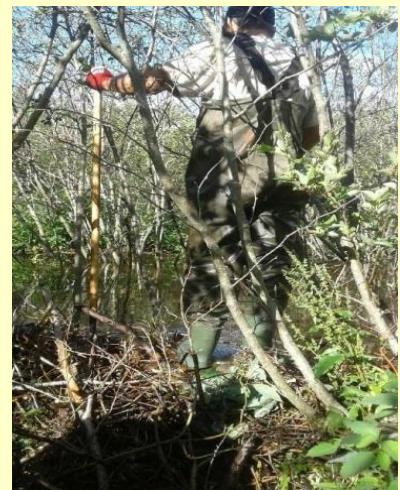
Beaver Dams at Marchbanks

CBWA staff discovered three beaver dams in the Marchbanks pond this summer - Two large dams, and one small one. The dams are causing some major blockages and debris is piling up. We have contacted the local trapper, and once the beavers are safely removed from the area we will repair the damages caused to this estuary. Our primary objective is to restore the normal stream flow while limiting the movement and impact of sediment stored within the beaver impoundments, and minimize the impacts on water temperature and dissolved oxygen. For more information contact John Lane at 902-856-1200.
